# Test report

Cantex Siliconen dakcoating

Cantex Dakrenovatie B.V.  
Milrooijseweg 47a  
5258 KG Berlicum Nederland  
Maarten Kuijpers  
info@cantex.eu  
21 October 2019  
0390-L-19/5  
K. van Zee  
determination of resistance to  
artificial weathering

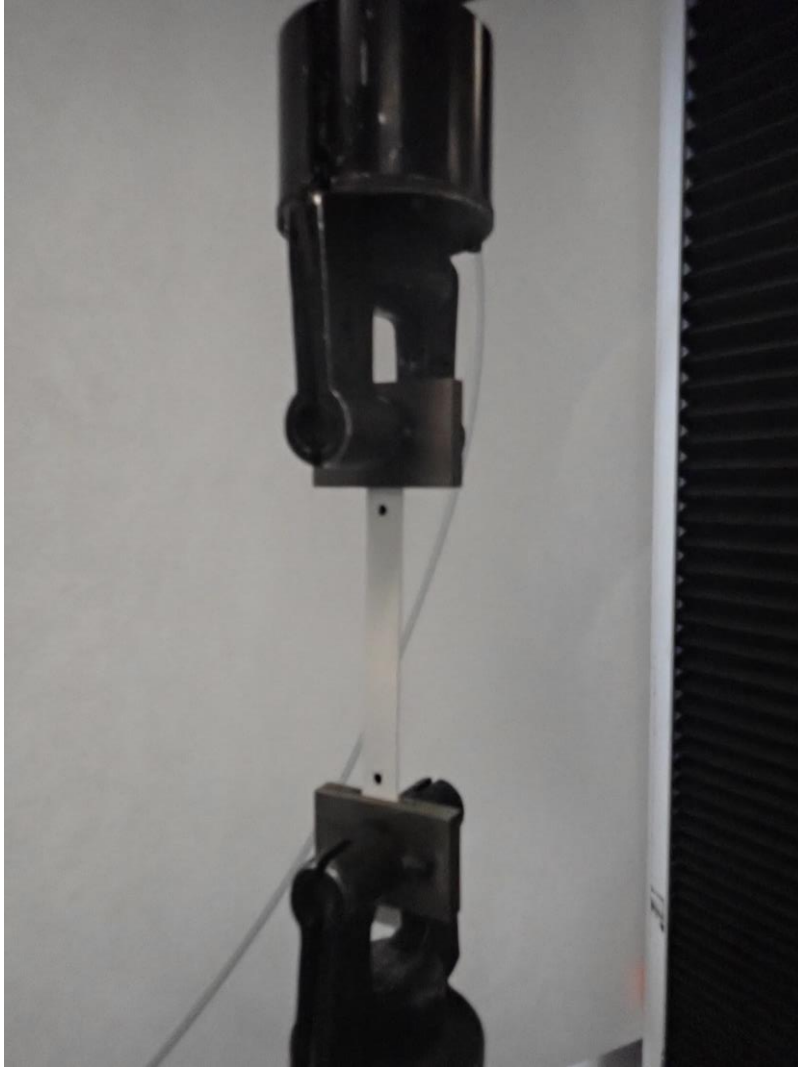
**Photo 3** – Determination of the tensile stress and elongation

Met opmerkingen [ZKv3]: Photo 3 Tensile test (detail)

The investigation into the tensile stress and elongation has been performed according to EN 12311-2:2013 – Flexible sheets for waterproofing – Determination of tensile properties – Part 2: Plastic and rubber sheets for roof waterproofing, Method B, with rectangular test specimens. The actual elongation of the test specimens has been measured with an optical extensometer; the constant separation speed has been set at 100 mm.min<sup>-1</sup>. See photos of the test in annex II.
